**Jurisdiction:** KIRKLAND  
**Project Name:** EOS  
**Application ID:** 227792

TSE'S PRELIMINARY SHORT PLAT

**TREE PLAN FOR  
12626 NE 105<sup>th</sup> PL  
Kirkland, WA**

**PARCELS #6743700315**

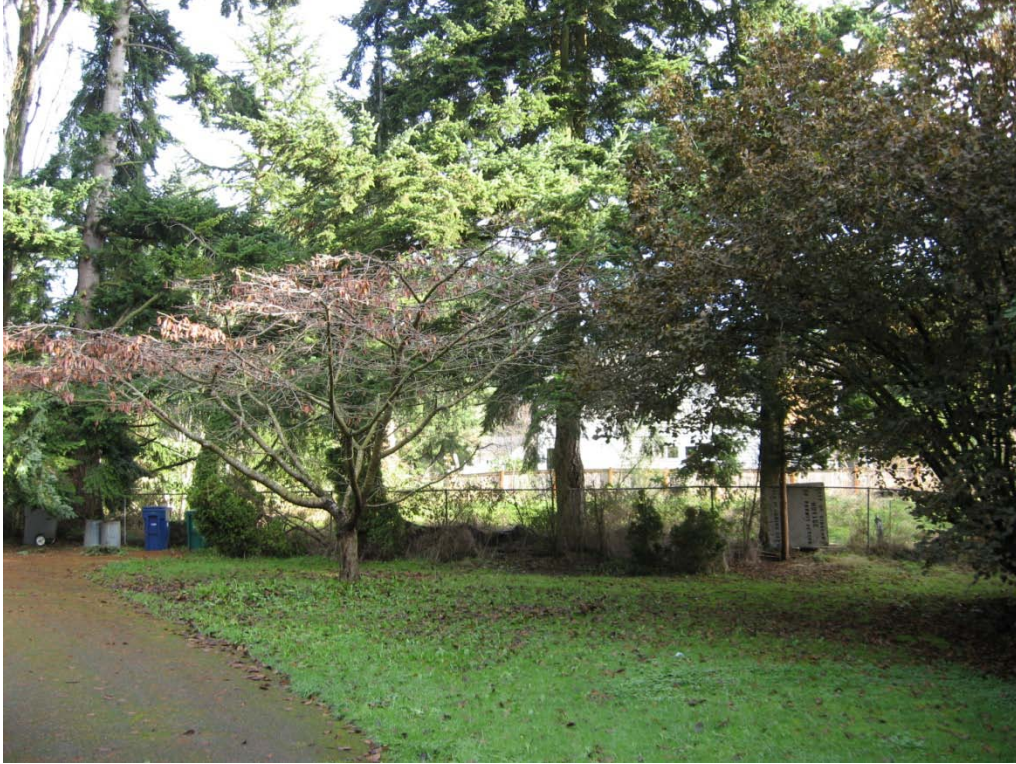
Tree #101 is a mature flowering cherry. The diameter was measured at one foot above ground, because the main trunk forks below DBH into multiple scaffolds. No concerning defects were observed. Vigor appears good.

Tree #101, with neighboring trees #201 > #204 in background, large shrub on right is a beaked hazelnut

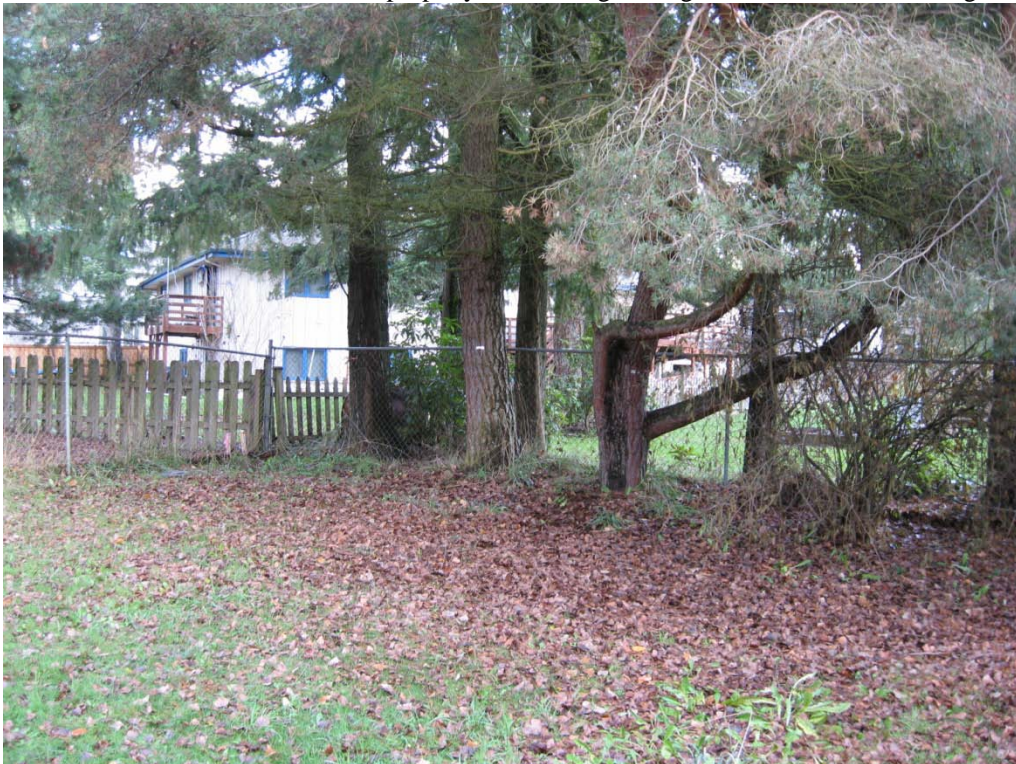
Tree #103 is a semi-mature to mature Scots pine, also situated close to the east property line. It also leans southwest away from neighboring poplar trees. The lower trunk has excessive sweep but is not considered a major defect. Overall condition is fair.

Tree #104 is a young to semi-mature Douglas-fir, also situated near the east property line, close to the northeast corner. Vigor appears good. The main central leader appears to have broken out of the tree in a recent windstorm. Foliage is of good color and density. No major defects were observed.

Trees #103 and #104 near northeast property corner, neighboring trees #215>#217 in background

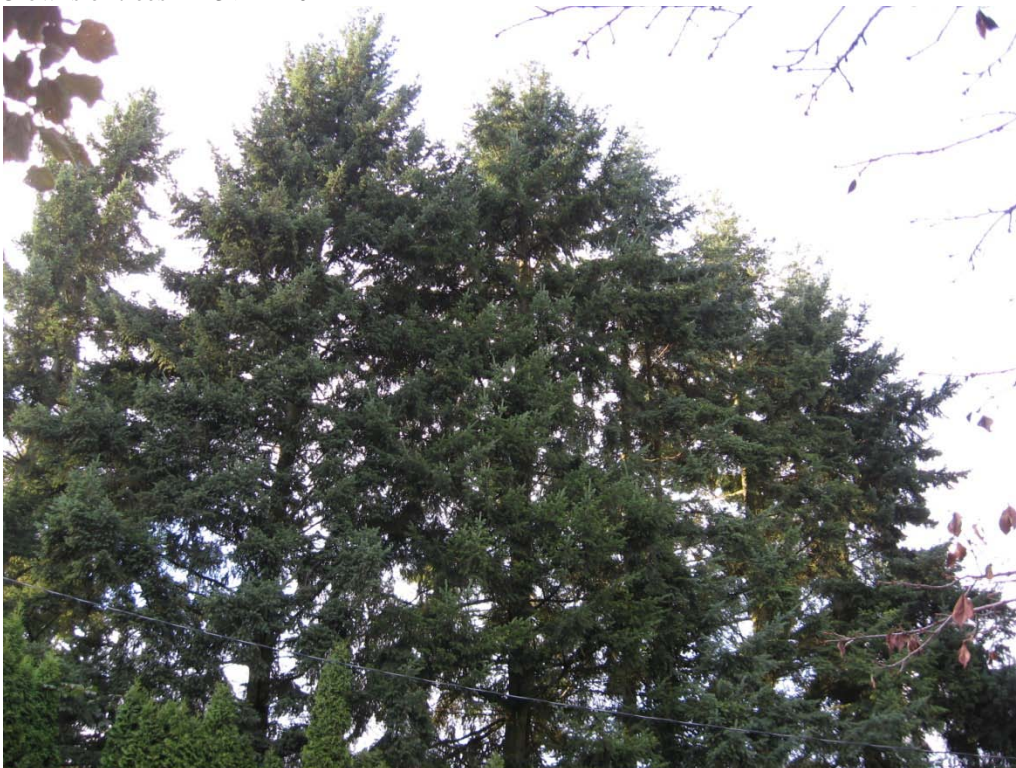
Trees #113 through #121 are semi-mature Douglas-firs. All are of similar age and size, planted at the same time. Foliage color and density is excellent. Most have developed good trunk taper with full crowns. Trees #113, #114, #118, #119 and #120 are in good condition with no concerning defects.

Crowns of trees #113 > #120
